Evaluation of Durability of Water Distribution Reservoir with the Reinforced Concrete Structure Utilized for 90 years

I. Okado*, H. Taniguchi**

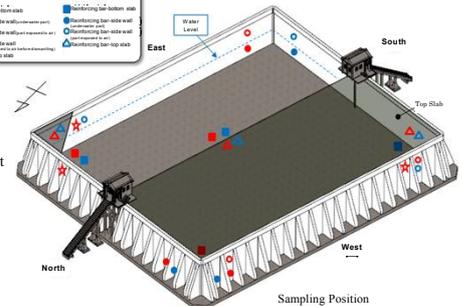
- Core samples were taken from the bottom slab, side walls, and top slab, with samples of the side wall taken for both the underwater part and the part exposed to air in consideration of the water level during use

- Surveys were conducted both inside and outside the structure for the side walls and top slab
