## Case 4 : Worker lost his balance and fell down while dismantling scaffolding

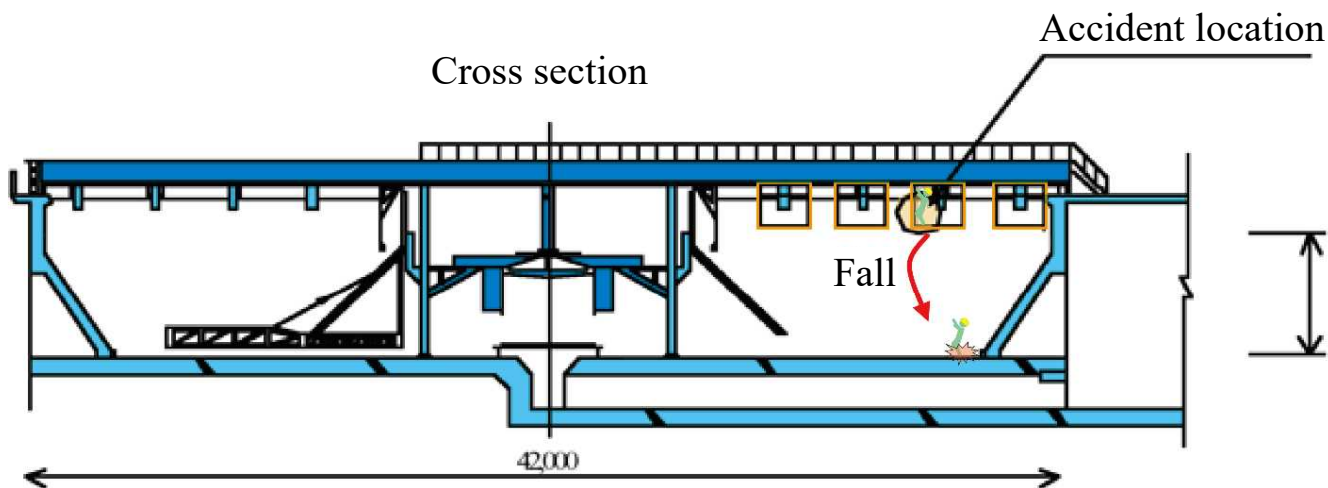
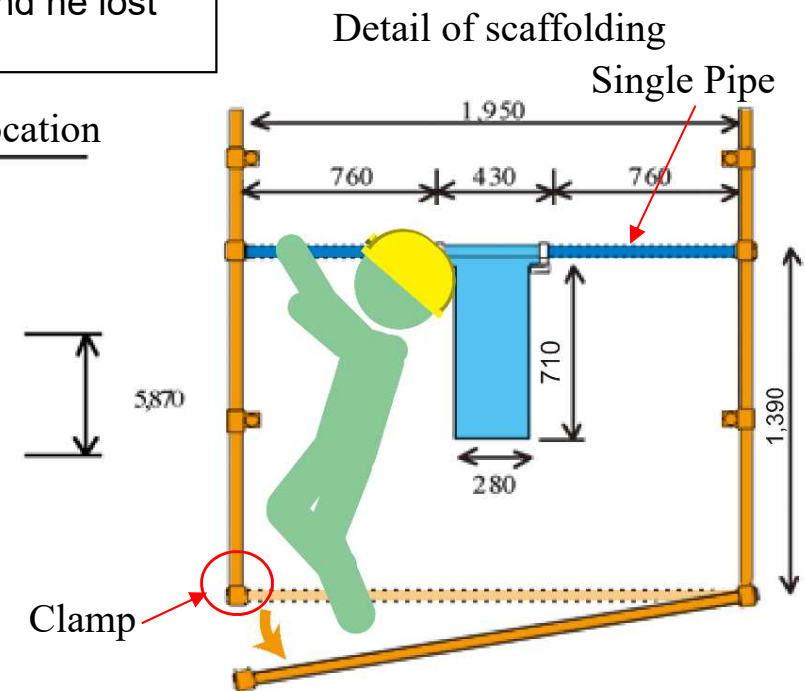
While dismantling scaffolding boards, the worker was working with using the fall prevention device on a single pipe, and he temporarily removed the fall prevention device to move on to the next job. When moving, the clamps on the single pipe which were supporting the scaffolding boards were come off, and the worker lost his balance and fell down.

- The fall prevention device was removed while working in a high place.

- Injuries (heel fracture, elbow fracture, sprained ankle)

- When worker temporarily removed the fall prevention device, scaffolding boards were come off, and he lost his balance and fell down.

- Use fall prevention devices when assembling and dismantling scaffolding.
