# Prevention of Leakage in Tokyo

2023

Bureau of Waterworks, Tokyo Metropolitan Government

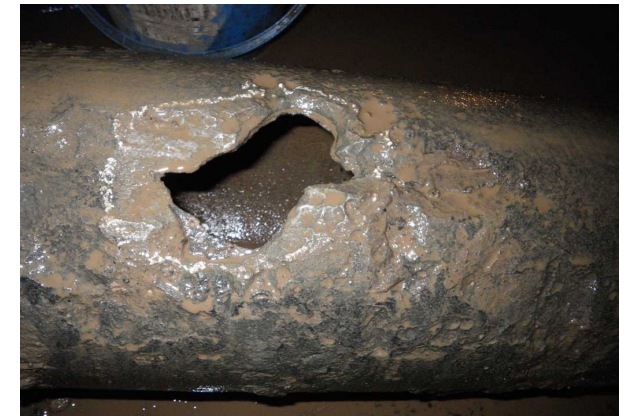
**Fig.2 Corrosion leakage of iron pipes**

Water pipes embedded in underground are constantly subject to a danger of leakage, affected by earthquakes, uneven ground settlement, corrosive soils, traffic loads, and various construction works, and so on.

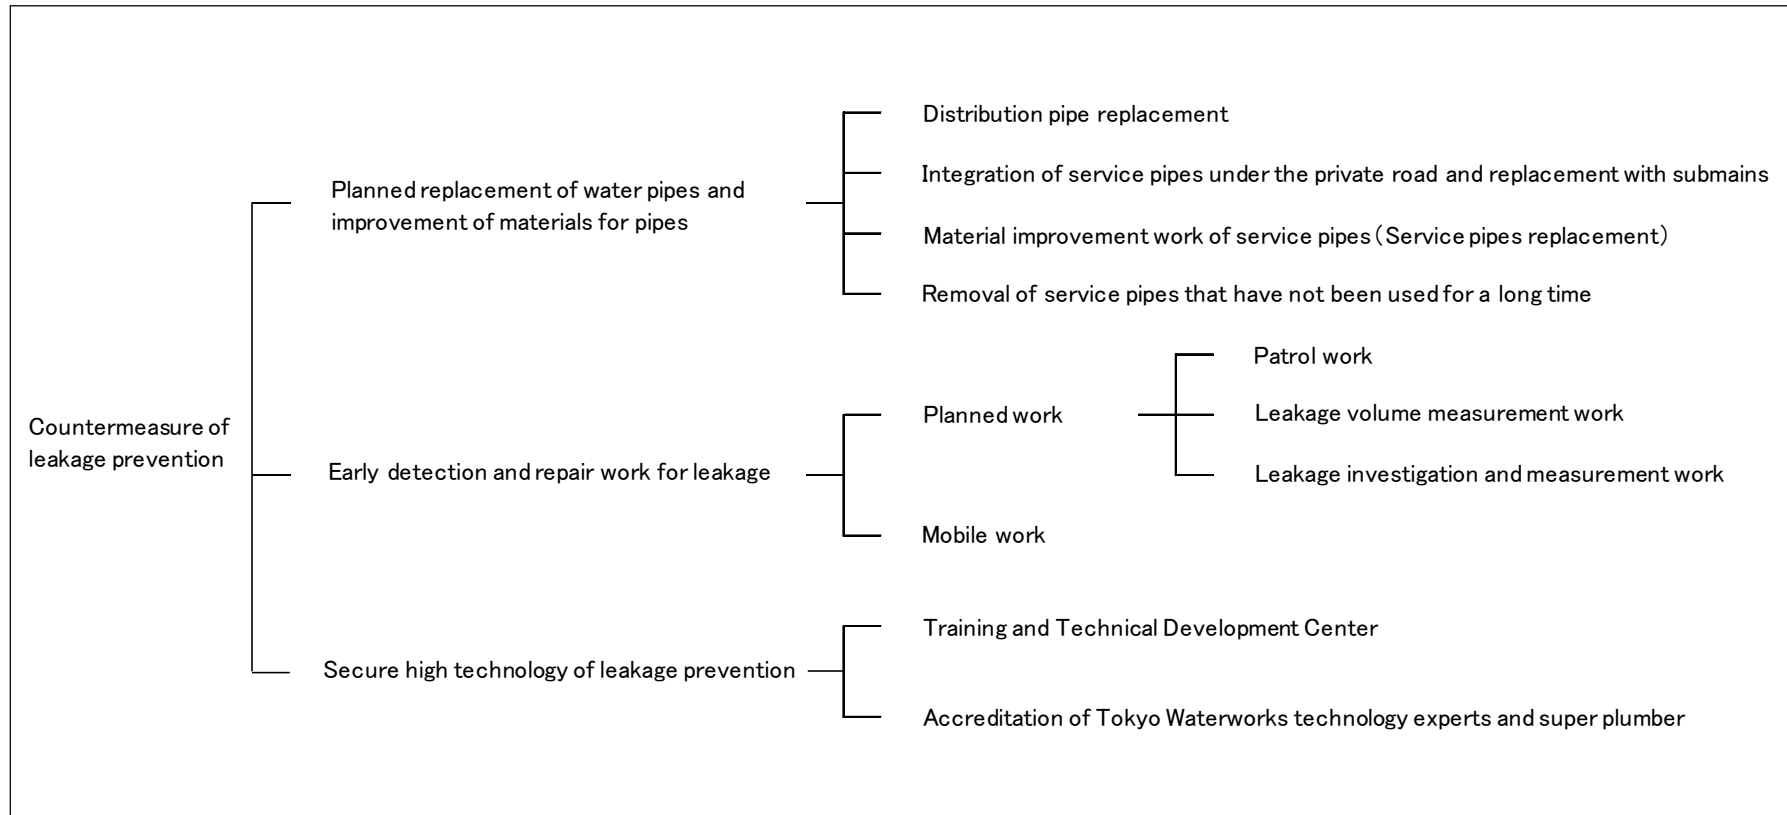
**Fig.6 System of leakage prevention measures**

Tokyo Waterworks is working on leakage prevention measures based on the pillars of “Planned replacement of water pipes and improvement of materials for pipes”, “Early detection and repair work for leakage” and “Secure high technology of leakage prevention”.

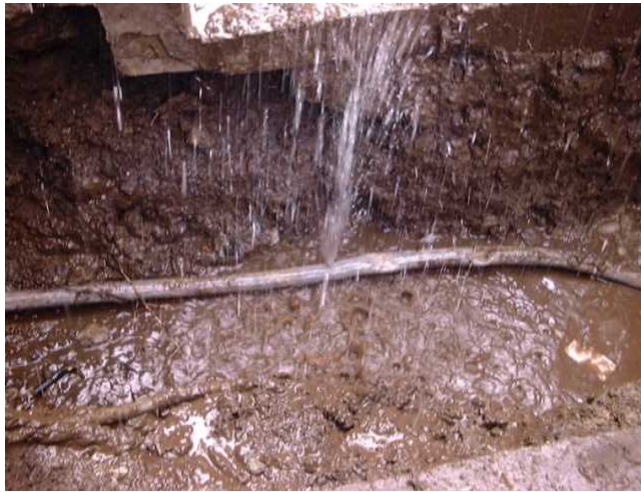
**Fig.11 Leakage from lead pipes**

Most of leakages occur in old and corroded service pipes (Reference-3), and they are accounted for about 97% of the total leakage repair cases. Consequently, in order to reduce leakages, it is extremely effective to prevent from them in advance. In Tokyo, we used to use “lead” for service pipes which is easy to construct. However, lead has been a major cause of leakages due to its low intensity and easy to corrosion.

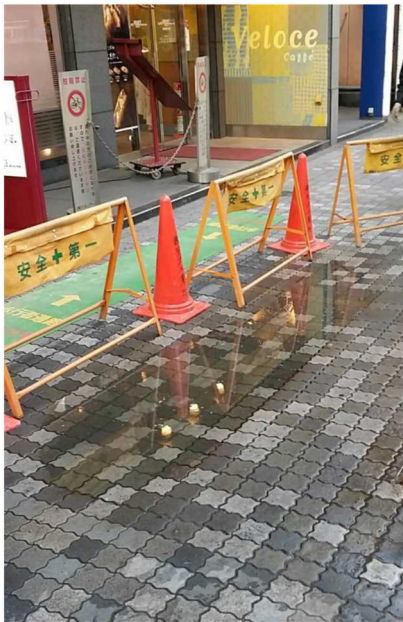
**Fig.14 Service pipe leakage  
(seep through to the surface)**

More than 90% of the leakages in Tokyo occur in the service pipes that supply water to each household. In particular, poorly managed service pipes laid in vacant houses are left for a long time, leading to delays in finding leakages. If these pipes are not properly managed, they will not only lose valuable water, but also lead to secondary damage such as road subsidence. In addition, if water leakage occurs at the time of a disaster, it is concerned that it may hinder prompt restoration.

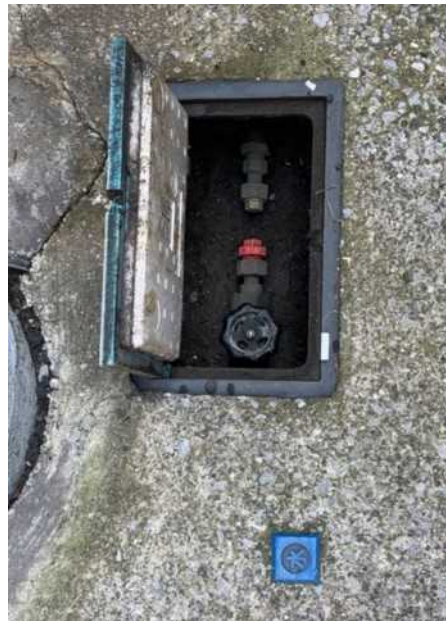
**Fig.15 The service pipe where water  
meter has been disconnected**

However, since 2021, from the viewpoint of avoiding the risk of leakage and optimizing the water supply environment, if the customer agrees, we have removed the service pipes that branch off from distribution pipes that have been made into earthquake-resistant joints and have not been used for more than 5 years.

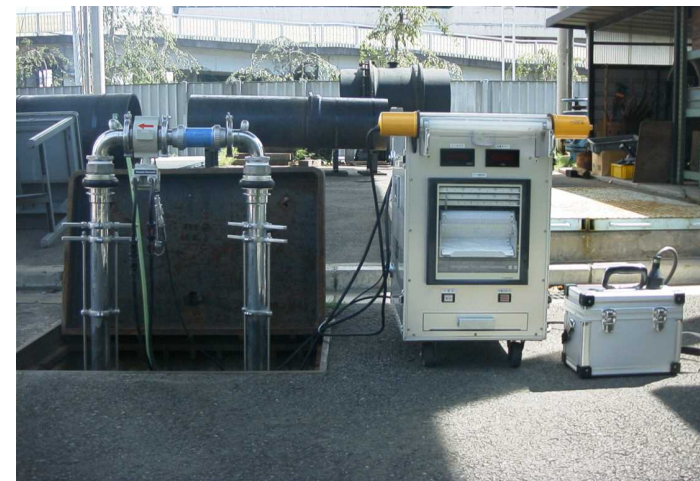
Fig.20 Minimum flow meter

This equipment is jointly developed by Tokyo Waterworks and a private company

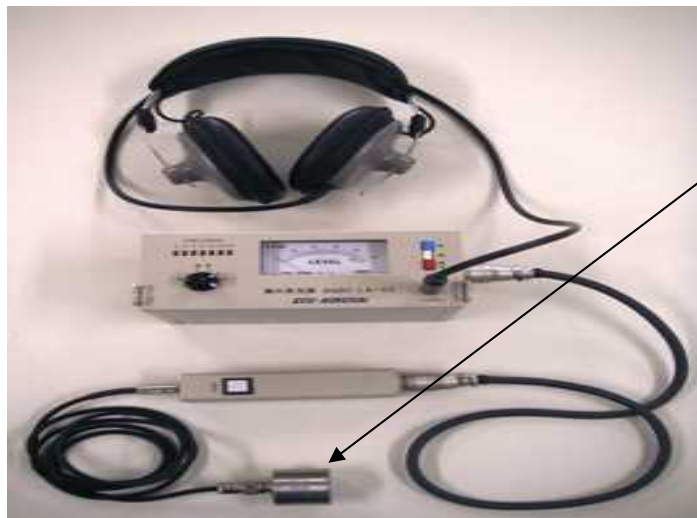
**Fig.22 Electronic leakage detector**

**Detector  
(Pickup)**

Electronic leakage detector is an equipment that can convert the leakage sound into an electrical signal by placed the detector (we called "Pick up") on the ground, and the sound is amplified and heard through headphones. We can search actual leakage point by moving the detector (Pick up) as leakage sound is heard most strongly directly above the point of leakage.

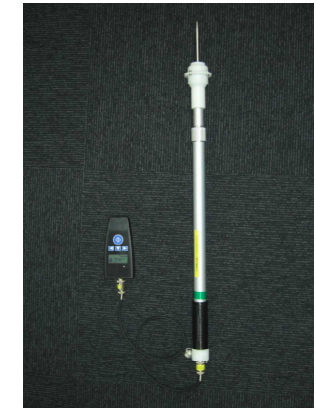
**Fig.26 Time integral type leakage detector**

In addition to that, we consign administrative organizations (Tokyo Water Co., Ltd.) to conduct such individual investigation with time integral type leakage detector (Fig.26) replacing leakage sound detection bar on some blocks since FY2003.

It has excellent characteristics such as being largely unaffected by intermittent sound of water use or traffic noise transmitted through the ground, and not requiring skill to operate.

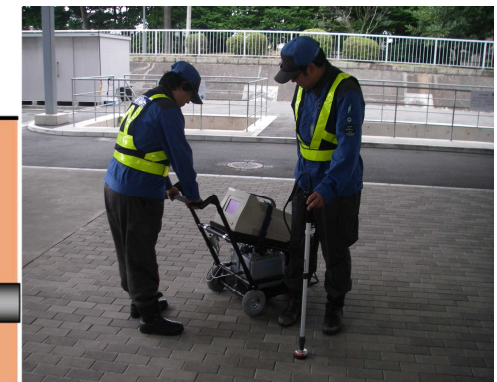
**Fig.27 Transmission-type leakage detector**

This type of method can detect very small amount of leakage or leakage in main pipes such as main distribution pipes buried deep underground since it is not based on the leakage sound as it is necessary with the acoustic leakage sound detection method or the correlative leakage detection method.

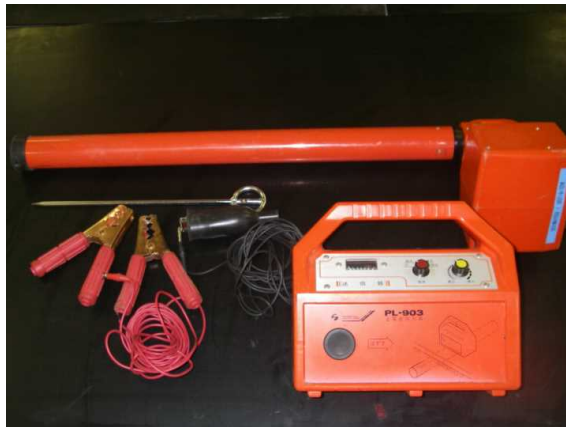
**Fig.28 Metal pipe detector**

Metal pipe detector and Water hammer Generator are used to detect the pipe location.

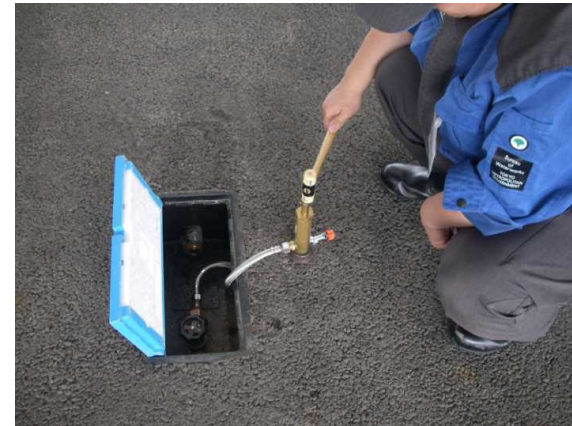
**Fig.29 Water hammer Generator**

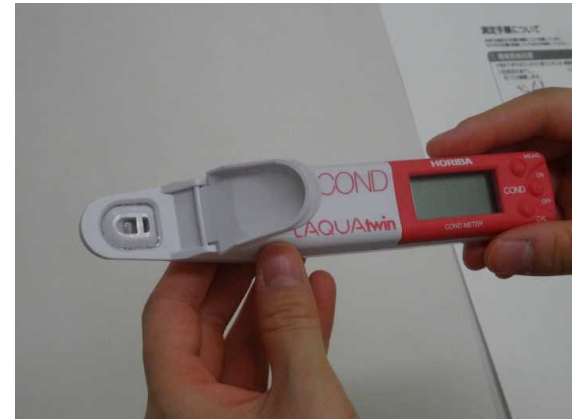
**Fig.31 Electric Conductivity Meter**

To identify water from tap, we use easy method such as water temperature gauge, residual chlorine analyzer, pH meter, and conductivity detector, or precise method determining inclusion of trihalomethane.

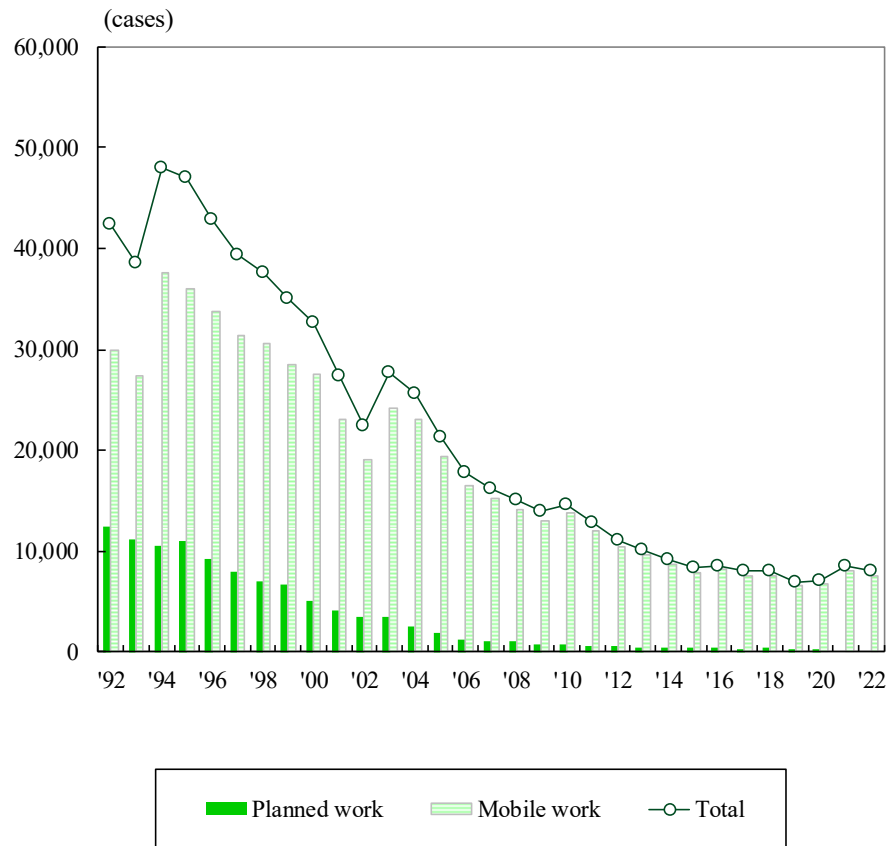
### Reference-4 Trends in number of each kind of repair works from FY 1992 to FY 2022

'92	'93	'94	'95	'96	'97	'98	'99
Planned work cases	12,383	11,142	10,505	10,979	9,177	8,028	6,964	6,627
Mobile work cases	29,960	27,337	37,542	35,965	33,757	31,345	30,575	28,476
Total cases	42,343	38,479	48,047	46,944	42,934	39,373	37,539	35,103
	'00	'01	'02	'03	'04	'05	'06	'07
Planned work cases	5,073	4,199	3,450	3,516	2,592	1,908	1,287	1,097
Mobile work cases	27,569	23,135	18,996	24,186	22,987	19,361	16,460	15,173
Total cases	32,642	27,334	22,446	27,702	25,579	21,269	17,747	16,270
	'08	'09	'10	'11	'12	'13	'14	'15
Planned work cases	1,026	848	801	684	542	503	454	434
Mobile work cases	14,083	13,046	13,777	12,090	10,476	9,597	8,752	7,881
Total cases	15,109	13,894	14,578	12,774	11,018	10,100	9,206	8,315
	'16	'17	'18	'19	'20	'21	'22	
Planned work cases	403	357	383	361	306	402	386	
Mobile work cases	8,168	7,620	7,623	6,618	6,790	8,097	7,628	
Total cases	8,571	7,977	8,006	6,979	7,096	8,499	8,014

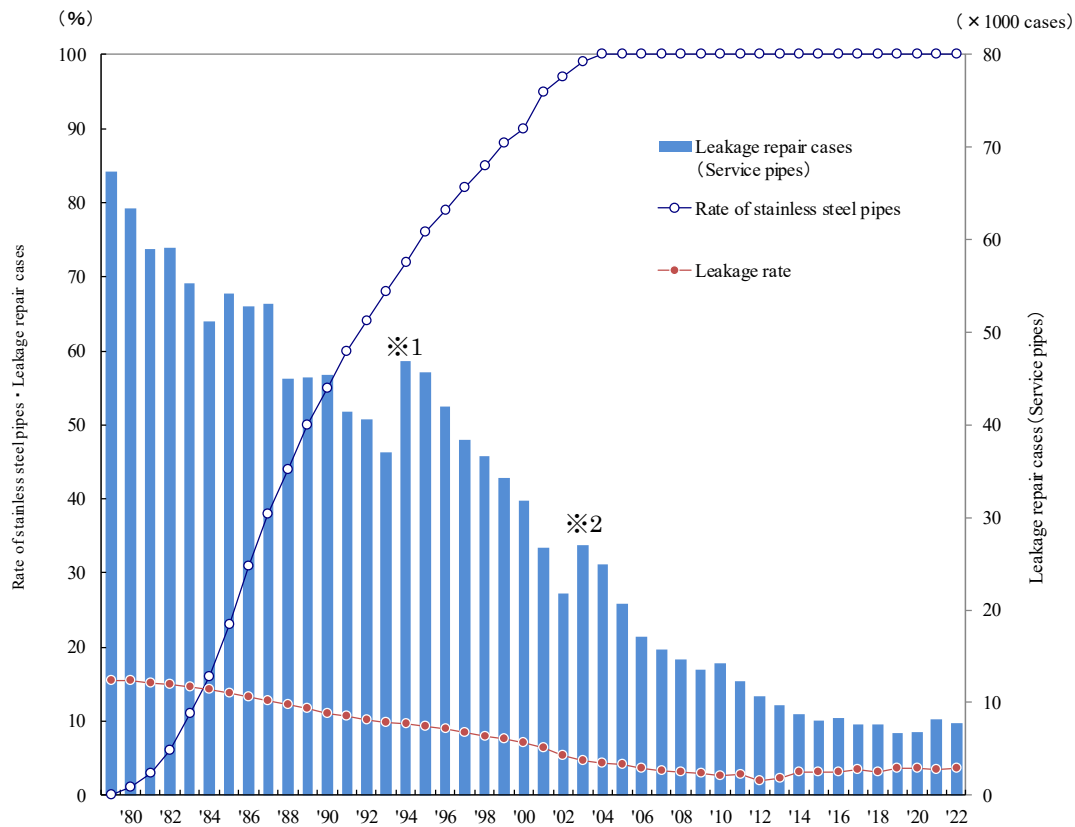
## Reference-6 Trends in rate of stainless steel pipes in service pipes, leakage repair cases(service pipes), leakage rate from FY 1979 to FY 2022

※1 We enlarged the repairing area range from “1m from residential border” to “water meter” in FY1994

※2 The reason of this rapid change in FY2003 was adding another topic
