Preparing for Various Threats in Tama Waterworks: Development of Facilities to Prepare for Disasters in Tama Waterworks

Abstract: Tokyo Waterworks must respond to new crisis risk factors that threaten stable water supplies, such as volcanic eruptions and acts of terrorism, and implement more effective measures of earthquake-resistance for pipelines and otherwise improve our crisis management in preparation for a hypothetical earthquake located directly under Tokyo. Due to these requirements, Tokyo Waterworks promotes the “Tama Waterworks Management Plan 2017,” a plan focused on the Tama area that includes measures such as improved earthquake resistance at waterworks facilities, the installation and increase of in-house power generation equipment, and the covering of water facilities with lids. For waterworks in Tama, Tokyo Waterworks is operating many small-scale facilities while seeking to expand operations over a wider area. These efforts of ours to prepare for various threats will serve to contribute to the promotion of efforts at other small- to medium-sized waterworks utilities.

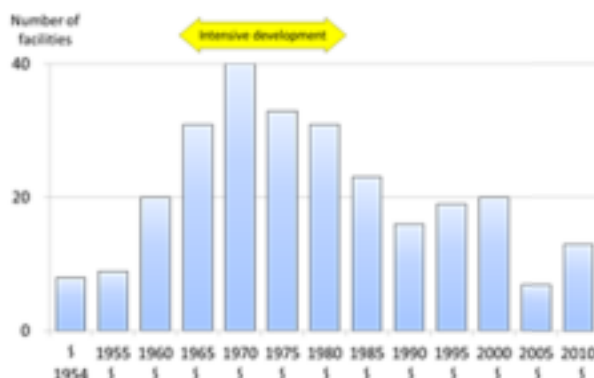
[Figure 2] The time when purification and distribution facilities in Tama area were developed

Many of the water treatment and water distribution facilities (excluding pipelines) in the Tama area were built around the period of 1965 to 1985 in particular (Figure 2). The proportion of facilities complying with Japan's earthquake resistance standards remains at approximately 30% of all facilities (Figure 3). This 30% includes facilities that were reinforced after being found to be lacking in earthquake resistance via seismic diagnosis, as well as those that were originally constructed with earthquake-resistant designs.

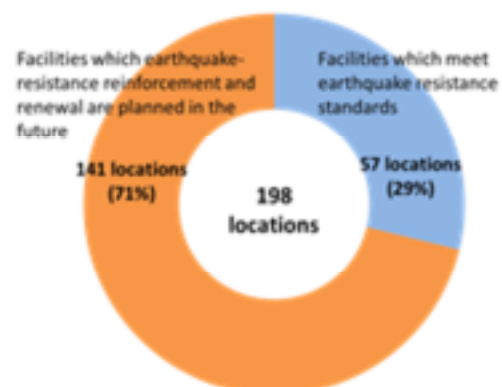
[Figure 3] Status of earthquake-resistance of purification and distribution facilities in Tama area (as of March 2016)

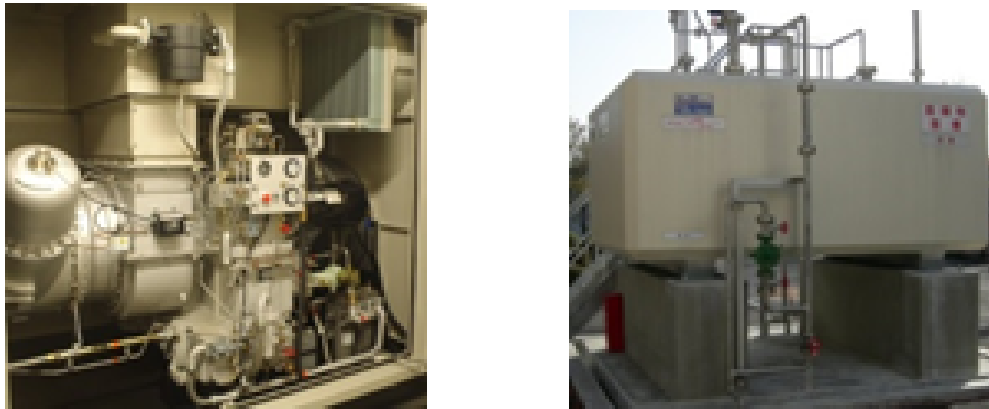
[Figure6] In-house power generation equipment and fuel tank

facilities sufficient to maintain average daily amounts of water distribution and to augment and expand fuel tanks (Figure 6).

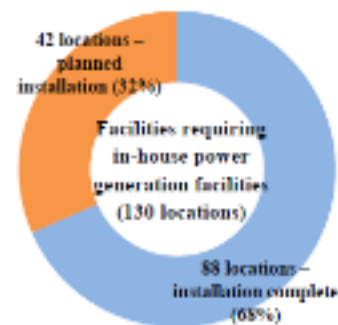
[Figure 7] Installation status of in-house power facilities (as of March 2016)

The installation, augmentation, and expansion of these facilities has been completed at around 70% of facilities requiring in-house power generation equipment (Figure 7). Of the remaining 30% at which installation is planned, facilities are prioritized that will cause water outages for all or part of their supplied areas in the event of a power outage.

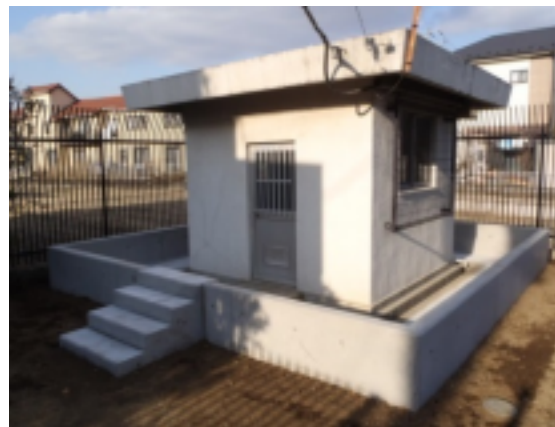
[Figure8] Construction example of flood

facilities have already installed cut-off walls and taken similar measures (Figure 8). However, each municipality publishes maps of predicted inundation depths under conditions such as record maximum precipitation levels in the
