Case 1 5 : Worker fell from framework, hit brace, and fell down to ground

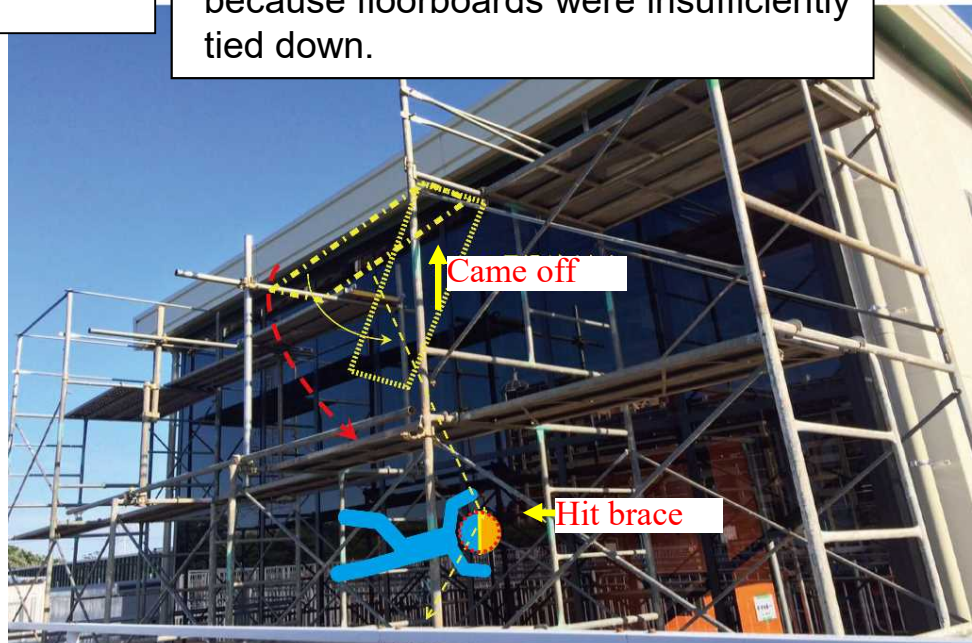
Because floorboards were not sufficiently tied down, worker fell and was injured when climbing up and down to assemble scaffolding.

- Handrail leading scaffolding was not used.
- Fall prevention device was not used.
- Floorboards were inadequately installed, and work was performed under unsafe conditions.

- Bruises on back and back of head

- When worker climbed onto scaffold to assemble, he fell down and injured because floorboards were insufficiently tied down.

- ① Assemble scaffolding by handrail leading method.
- ② Use fall prevention devices when assembling and dismantling scaffolding.
