Investigation of applicability of Smart Meter (multifunctional meter for water supply) to the city of Tokyo

Abstract: On-site experiments (field test) using Smart Meters are conducted by domestic water supply utilities in Japan. We investigated the possibility of utilizing a Smart Meter (multifunction meter for water supply) fitting the circumstances of Tokyo. This investigation verified the communication status and surveyed residents' satisfaction degree with service utilizing the information from communication equipment, by installing devices in homes of subjects living in Tokyo. The results showed the communication success rate was more than 95%, and the satisfaction rating with residents' service was more than 89%. In this survey, we obtained a new assessment on wireless communication performance and residents service as related to Smart Meters.

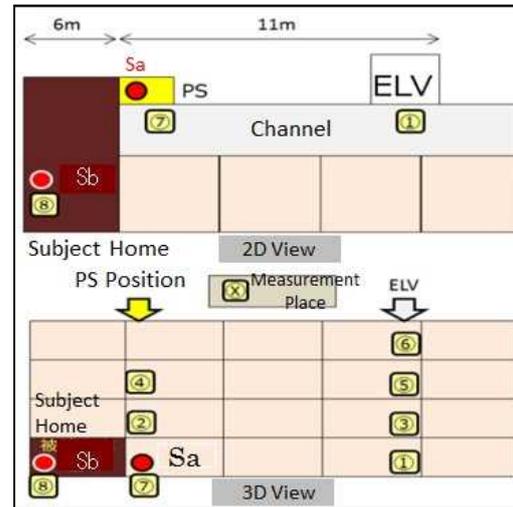
Figure 1. Transmitter & Receiver Installation Locations (Apartments)

In apartment buildings, because homes are in close contact with each other, sufficient communication could be obtained if wireless repeaters were appropriately arranged (Figure 1) (Table 1). For communication distance on the same floor, radio field intensity is -66.15 dBm (average RSSI) at 11 meters, the distance from the transmission point Sa to reception point 1, while radio field intensity is -91.58 dBm (average RSSI) at 17 meters, the distance from transmission point Sb to the reception point, and there were no errors (PER = 0%). From this result, it can be assumed that a radio

repeater installed at a distance about 17 meters away can accommodate a radio child unit on the same floor. On the other hand, regarding communication distance between floors, from test results of reception points 2 to 6, the radio field strength up to three floors away was -77.19 dBm (average RSSI) with no error occurrence (PER = 0%). From this result, it can be assumed that it is possible to accommodate child units two to three floors away.

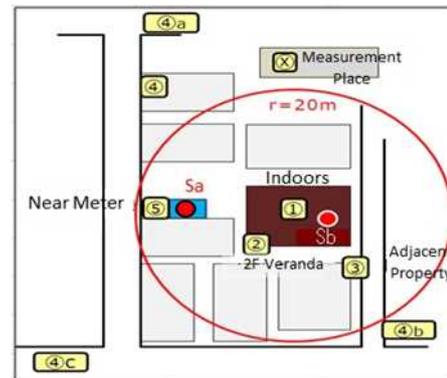
Figure 2. Transmitter & Receiver Installation Locations (Detached House)

In detached houses as well, we installed transmitters (Sa, Sb) and receivers (1 to 5) at assumed installation locations for wireless devices, and measured RSSI value and PER value between the transmitter and the receiver (Figure 2) (Table 2). Good results were obtained, with average RSSI = -59.33 dBm and PER = 0% at 5 MB, about 20 meters away from the representative house parent unit (Sb). Also, at 4 on the road about two houses or 30 meters away, average RSSI = -85.74 dBm, minimum RSSI was 101 dBm, and PER = 7.17%. From these results, it was found that it is possible to accommodate child units in an approximately 20 meter radius, taking into consideration the influence of building walls, cinder block walls and the like.

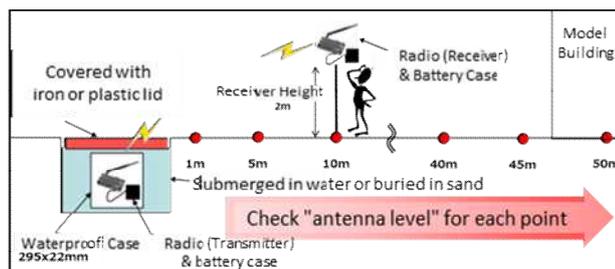
Figure 3. Overview of communication distance measurement

Before the field experiment, we measured the communication distance from the wireless child unit (water meter) in the MB to the wireless parent unit, at the experimental station of the Tokyo Waterworks (Figure 3). In low-rise houses, because the water meter is installed in an iron or plastic box of the same height as the ground, we measured the communication distance for each environment in the MB in each case (Figure 4).

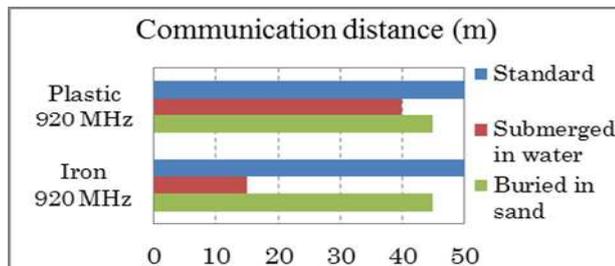
Figure 4. Comparison of communication distance

A trend was seen that the communication distance was shorter when the wireless handset was stored in an iron box than a plastic box. Also, cases where the radio handset is submerged in water or buried in the earth, the communication distance is shortened in both cases in the standard environment

(without inclusions), but it was observed that communication distance tends to be shorter in submerged environments.

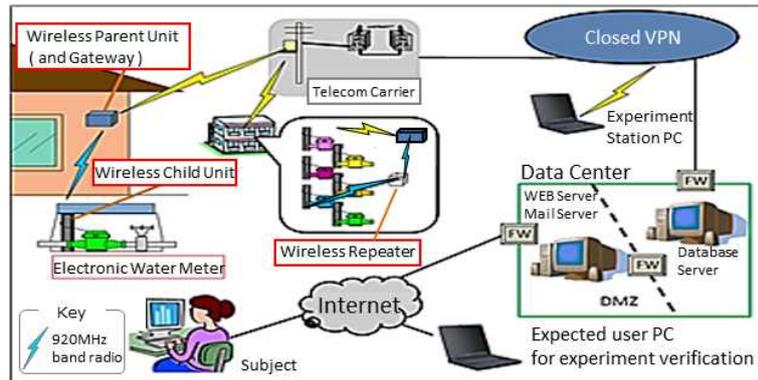
Fig. 5 Field Experiment Image Diagram

We selected collaborators living in Tokyo as subjects to conduct field tests (Figure 5). The implementation period was about 3 months, starting in August 2015.

Communication between the wireless child unit (water meter) and wireless parent unit (gateway) used 920 MHz band radio, and beyond that, the devices were connected to the communication network of existing domestic telecommunications carriers.

After finding and processing the accumulated amount of used water (1 hour unit) acquired from the water meter on servers, we provided residents' services such as sending email to the subjects.

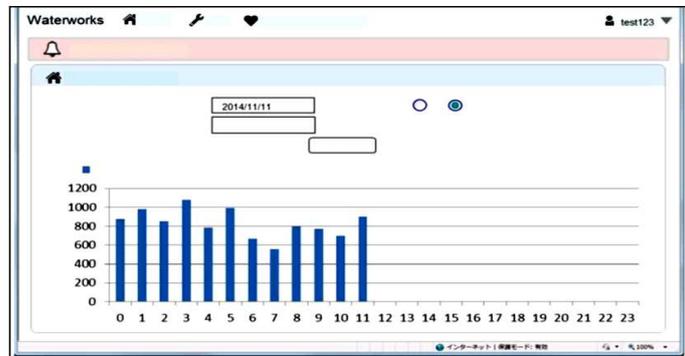
Fig.6 Examples of water usage visualization display

By visualizing the amount of water used, we made it possible for subjects to check their own water usage from various

perspectives (Figure 6).

Specifically, subjects can view the amount of water used by day and the amount of water used by month on the Internet, and compare it with past water usage (comparing amount of water used on two specified days or the amount of water used for two specified two

months) can be carried out. Also, subjects can receive notifications of the amount of water used every hour for the most recent 24 hours at a set time of their choosing, with a pre-registered e-mail address.

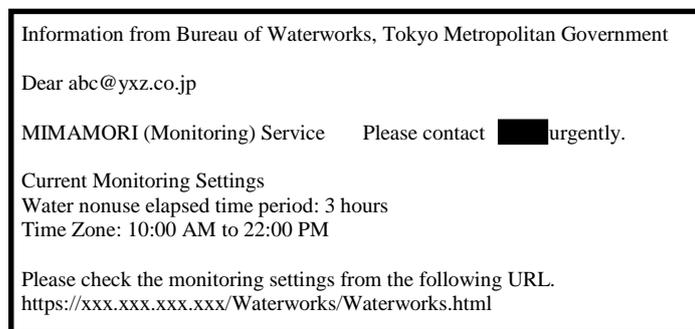
Fig.7 Examples of water usage abnormality notification

Abnormality detection is a function that notifies the subject by email when their water use is judged to be abnormal, so that subjects can detect abnormalities as soon as they occur (Figure 7). There are two different situations which will be determined to be abnormal water use. One case is when water uses late at night and other times are determined to be a water leak, while the other is when water is not used during a time of day it normally is used and determined to be an abnormality (Figure 8).

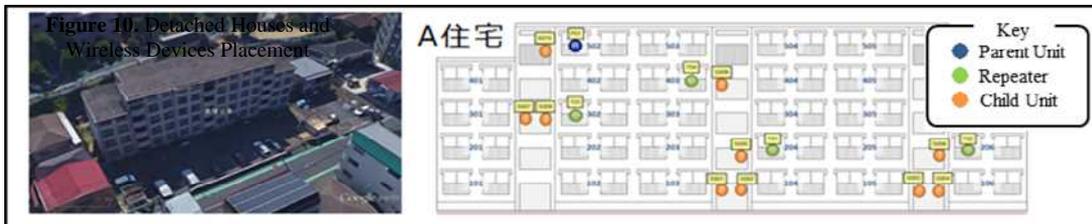
Figure 9. Apartment Buildings and Wireless Devices Placement

In our field experiment, we measured radio waves in advance for each home, and referenced the results to decide the arrangement of wireless devices (Figure 9) (Figure 10). Items we measured beforehand include the RSSI and the PER between the transmitter and the receiver, which were based on a value of -90 dBm or more and a PER of less than 0.1%, respectively. The communication success rate over the entire field experiment was 95% or higher for many subjects, but lower for others.

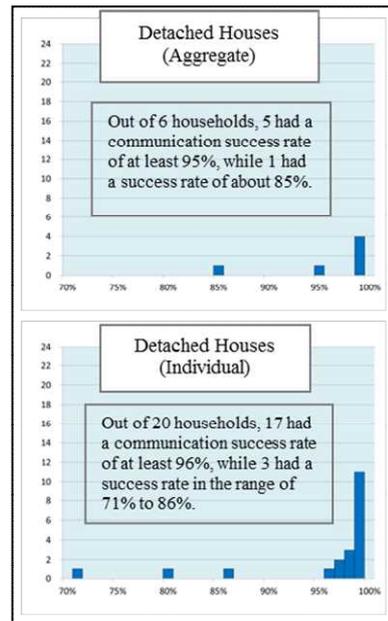
Figure 13. Communication Success Rate Distribution (Detached Houses)

In detached houses (aggregated type), 5 out of 6 test subjects had a communication success rate of 95% or more, with 1 unit relatively low at about 85% (Figure 13). The aggregated-type transmission method has an advantage in areas where detached houses are densely clustered, as it is possible to communicate using fewer communication devices. Yet, one challenge is the need to organize the conditions of aggregation when it is actually introduced. For detached houses (individual type), 17 out of 20 test subjects had a communication success rate of 96% or more, but 3 houses were relatively low, at a level of 71% to 86%). As a result of verification, we believe that this is caused by deterioration of reception

due to physical environmental change such as opening or closing shutters or how cars are parked.

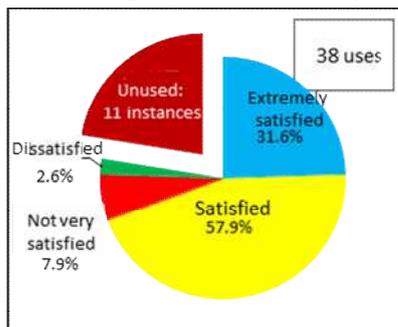
Fig. 14. Satisfaction level of water usage visualization

About 89% of the service users were satisfied or very satisfied with visualization of the amount of water used, so it was generally well received (Figure 14). There was a tendency seen that the subjects use this service less frequently in the second half compared with the first half of the experiment period (Figure 15). We believe that the frequency of use decreases due to the sense of security gained from knowing it that can be displayed at any time. It is also important that residents' services are not just well received, but continue to be used. There were also issues with display, as some subjects say that the time display was confusing.

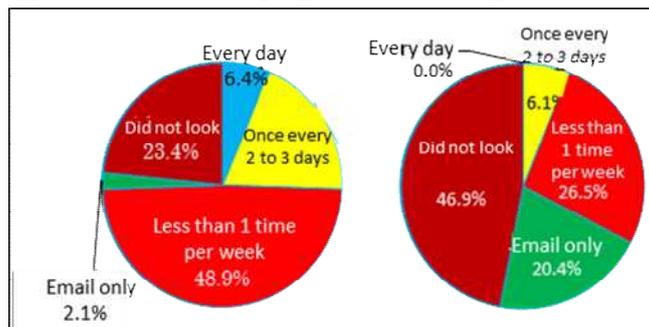
Fig. 15. Trend to lower frequency of use (Left: 1st Half, Right: 2nd Half)

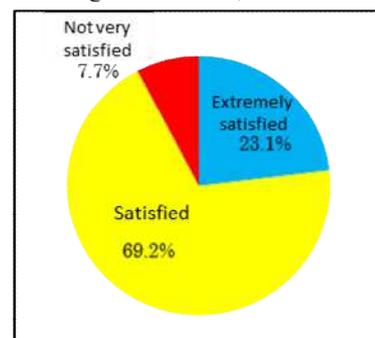
Fig. 16. Satisfaction with abnormality detection (water not used)

For abnormality detection (not using water), there were less than 10 subjects, which was fewer than visualization of water usage, but about 92% of service users were satisfied or very satisfied (Figure 16). While the time span can be set freely, some subjects complained that it was difficult to set the time. It was clear that improving ease of use is a critical task in increasing the number of users.

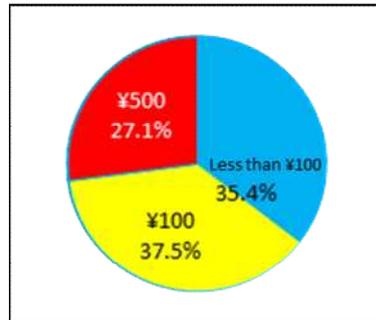
Fig. 17. Appropriate monthly price of visualization

A questionnaire survey was conducted about fees (monthly fee) considered to be reasonable for use of services, for both visualization of the amount of water used and abnormality notifications, and a majority of respondents answered that they would like the monthly fee to be 100 yen or less (Figure 17) (Figure 18). We calculated the earnings and expenses of service with this fee, and found that it would be difficult to operate the service.

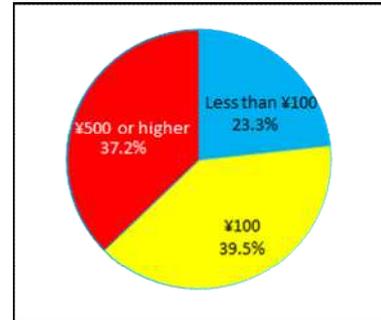
Fig. 18. Appropriate monthly price of abnormality notices
